Final Report

of the Inspection of
the Home Located at

Tim Sayre

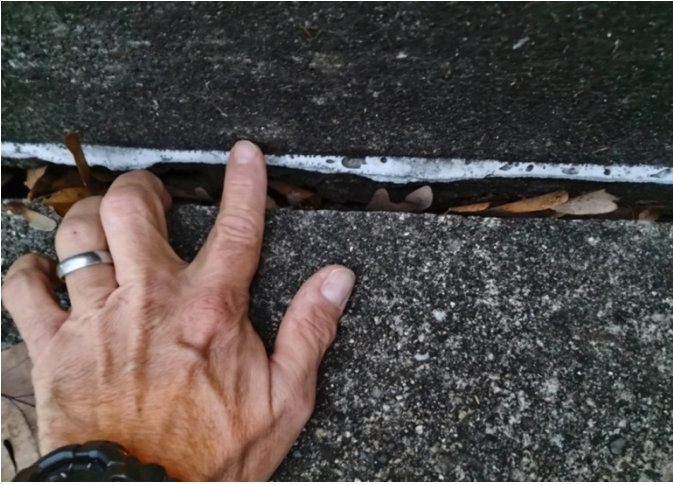
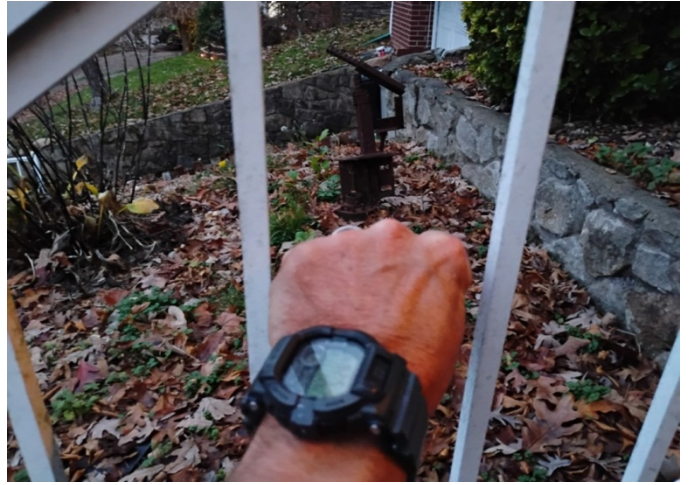
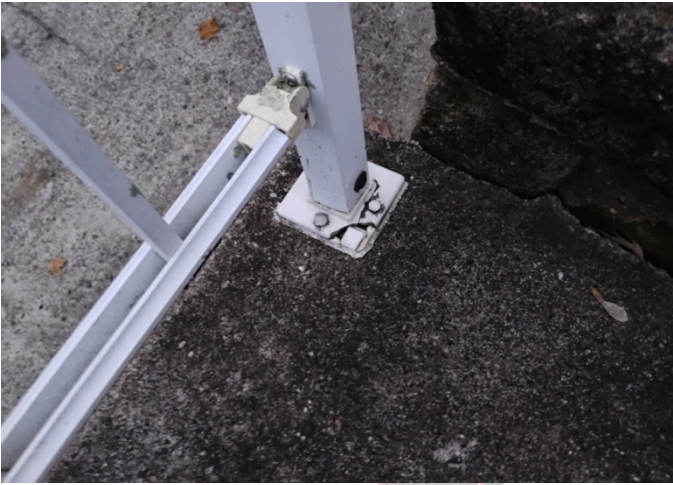
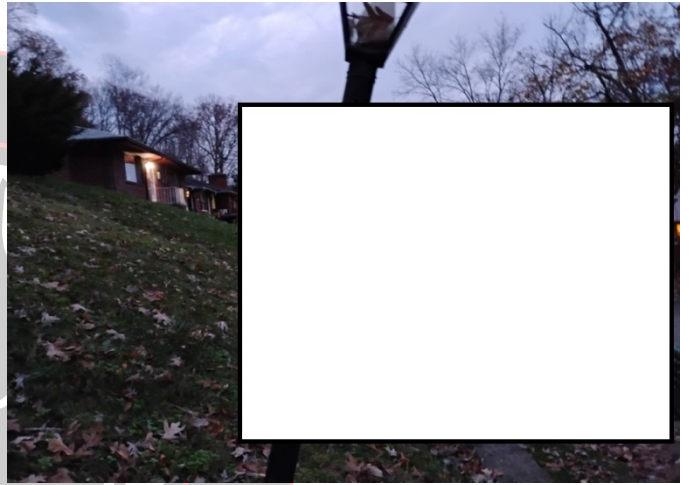
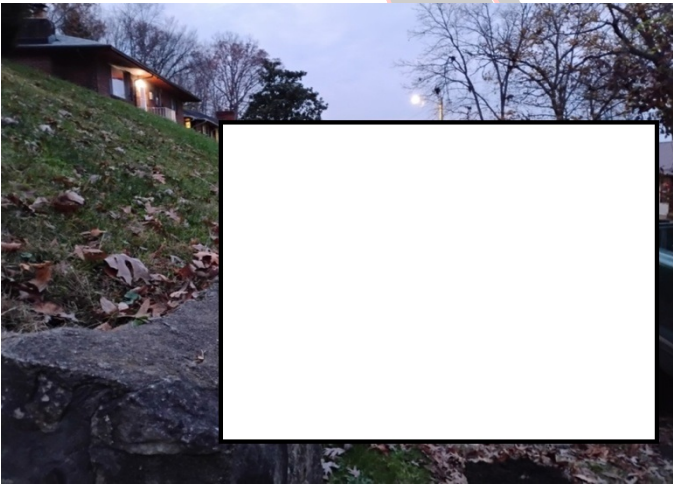
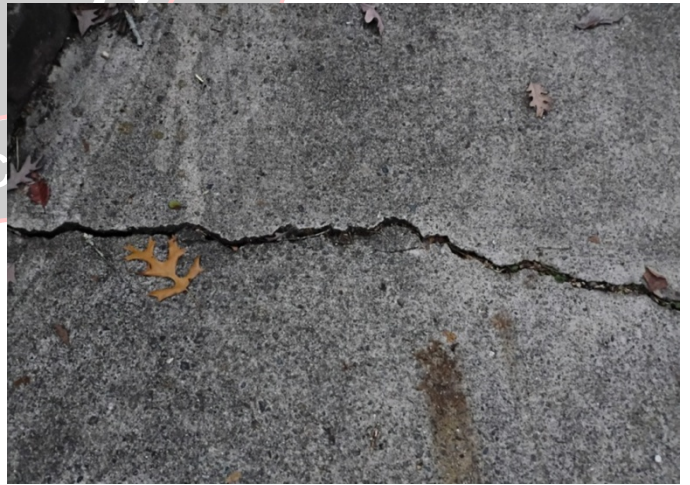
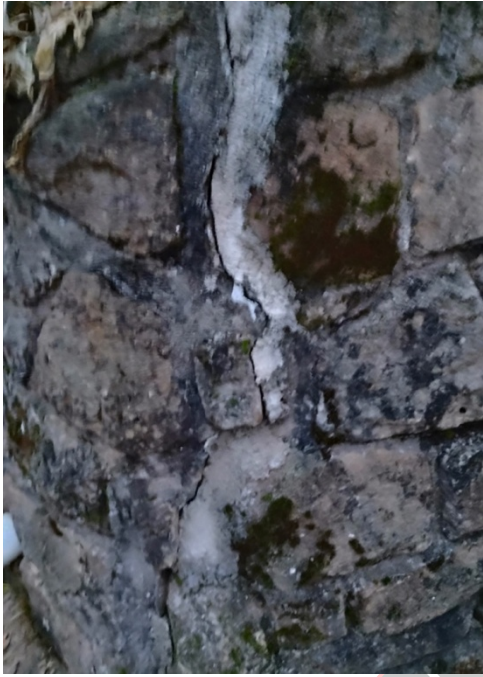
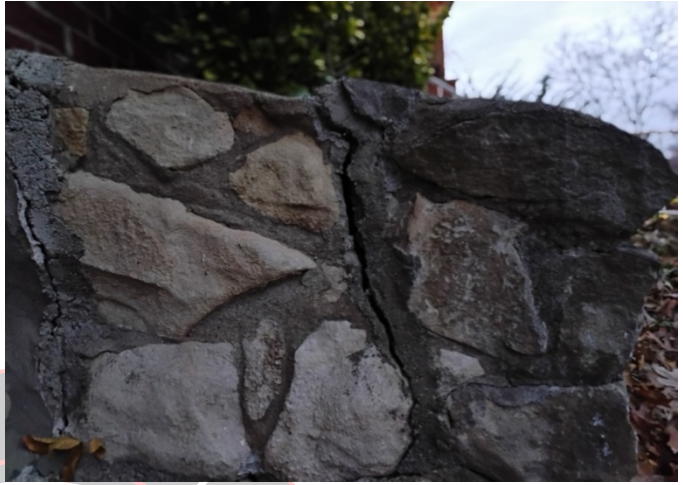
There were signs of erosion as well as signs of former trees in the front. There was a large shrub on the north side of the house, a small tree on the west side, and several large trees on the south side wooded area, including several which have fallen. Retaining wall in the front was leaning as was part of the wall on the east side of the driveway while the retaining wall in the rear appeared relatively straight. All of the retaining walls showed signs of cracking as well as repairs of various ages. There was a raised flower bed in the front of the house which has cracks and other signs of movement and is in need of attention soon by a qualified licensed professional.

The steps and sidewalk leading up to the house were cracked in places. One handrail support was broken and the spacing of the balusters was greater than four (4) inches, both of which are safety concerns. The driveway had a very steep angle and is heated. The heating system was not operated at the time of inspection and it is recommended to be evaluated by a qualified licensed professional before first use. Spalling, cracks, and separation from the garage were all observed at the time of inspection. The lamp post in the front yard near the retaining wall was leaning approximately eight (8) inches from vertical. I recommend further evaluation by a qualified licensed professional.

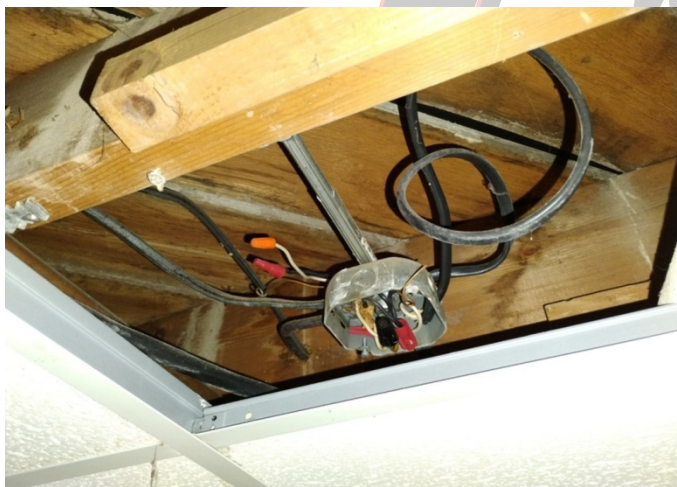
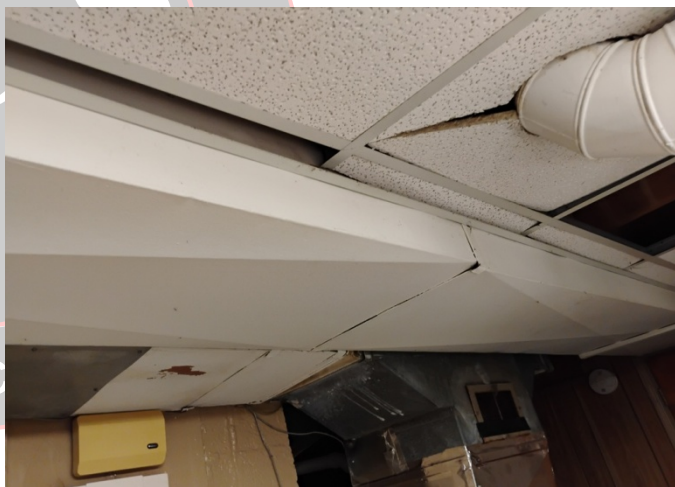
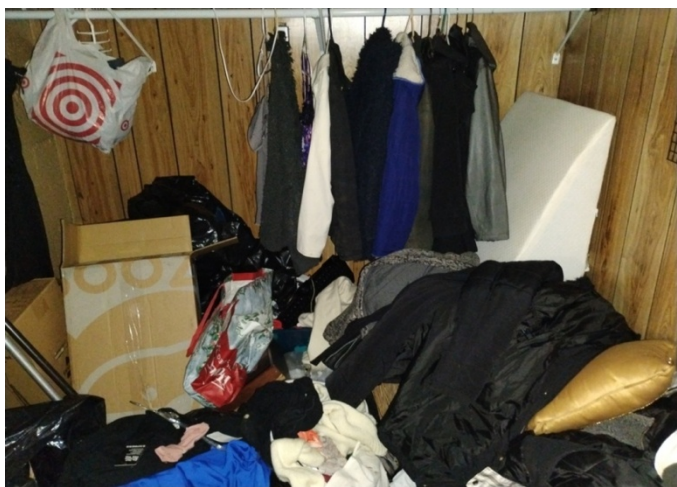
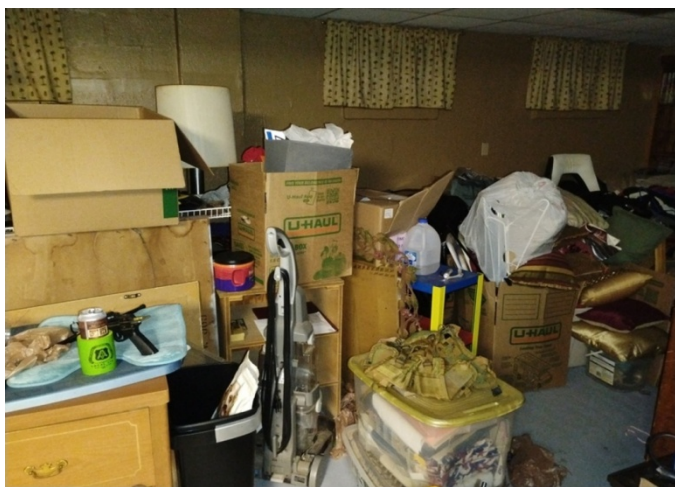
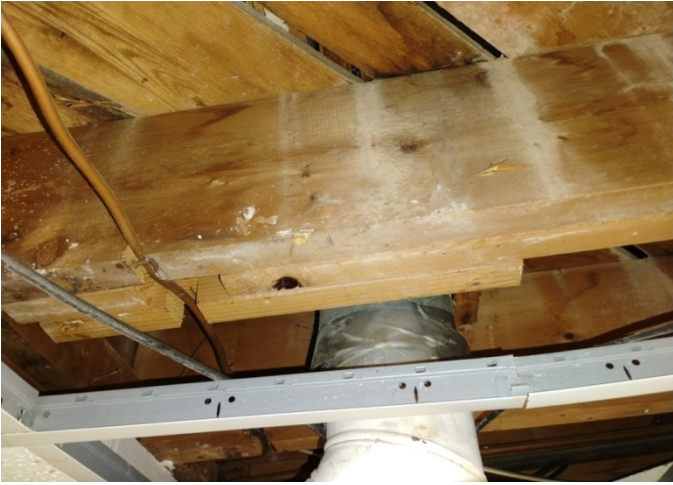
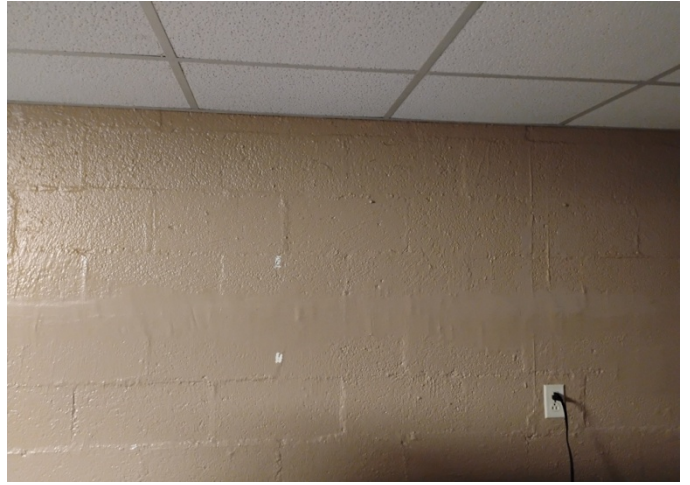
The basement is partially finished and was mostly obstructed by stored personal items. The foundation is made from CMU blocks which had been painted on the inside. The circuits were not protected by Arc Fault Circuit Interrupters (AFCIs), and although this is a modern standard and was not in effect at the time of construction, it is a good idea to bring the house up to modern safety standards. The floor covering was tile laid on concrete which has been painted. Cuts in the floor were observed where a drain appears to have been replaced and/or worked on. There was a grid ceiling with tiles which prevented inspection of the underside of the floor system but there were a few tiles not in place which allowed for a limited view. Wire nuts which were not in a junction box were observed, as well as a notch cut in the middle of a floor joist, both of which are safety items and need further evaluation from a qualified licensed professional and corrective action taken as deemed necessary. The door to the garage was not self-closing nor was it fire rated for 20 minutes as required by modern safety standards.

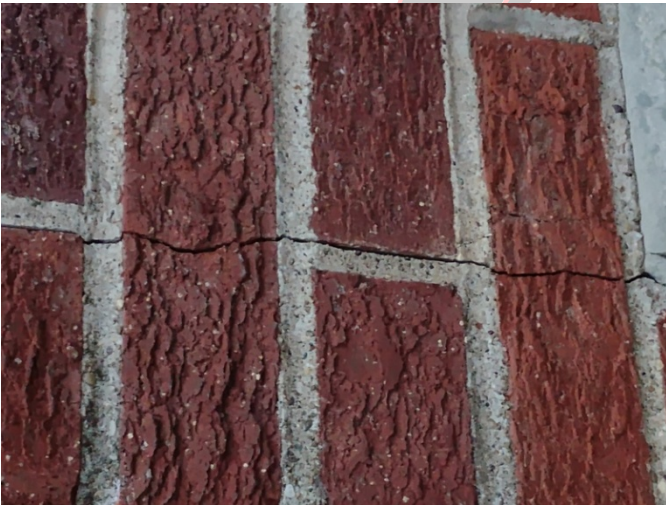
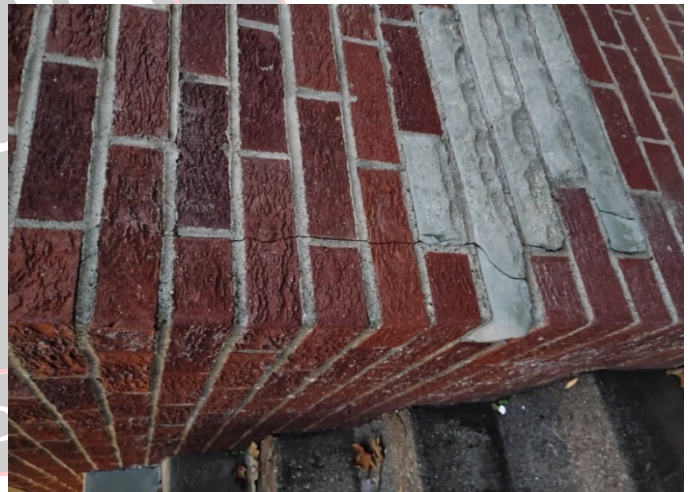
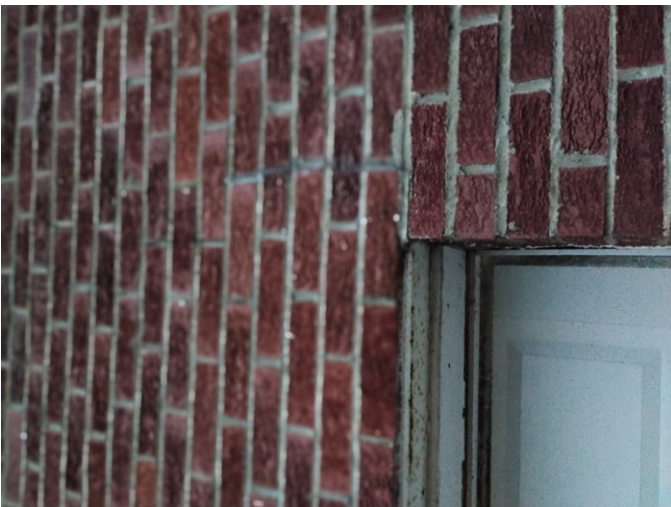
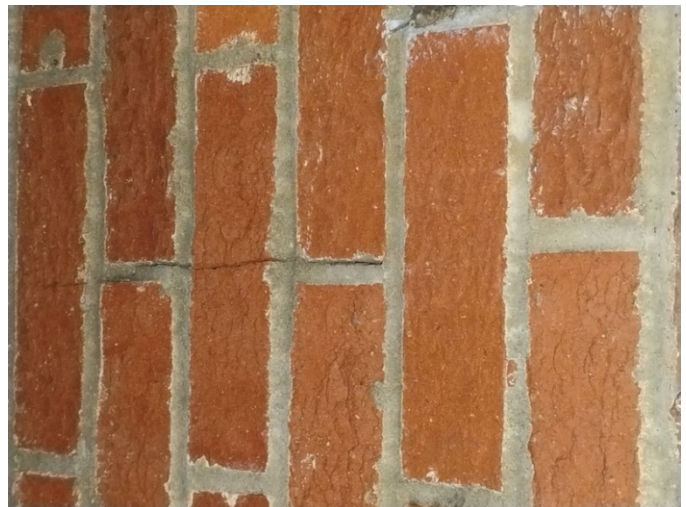
At the time of inspection, cracks in mortar joints and broken bricks throughout the home were observed, particularly on the front with hardly any on the rear, with the exception of some cracks in the patio. A qualified licensed professional is recommended to evaluate them further and corrective action taken as needed. Any time cracks are observed on the exterior, special attention must be paid to the interior to look for signs of structural failure which need to be further evaluated. A home inspection cannot tell you if a crack is moving or getting worse, just that it exists.

The front storm door had a broken latch, the back door had a deadbolt that is operated by a key on both sides, and locks should be changed or re-keyed when moving into a new home. All of these actions should be evaluated by a qualified licensed professional and their recommendations acted upon as needed.

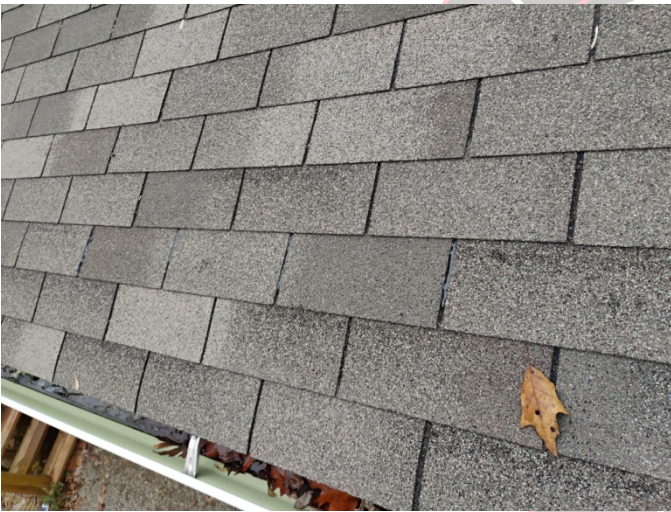
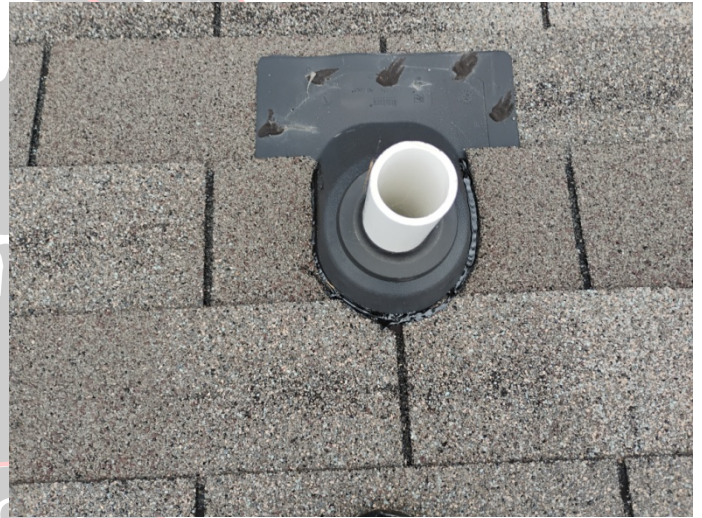
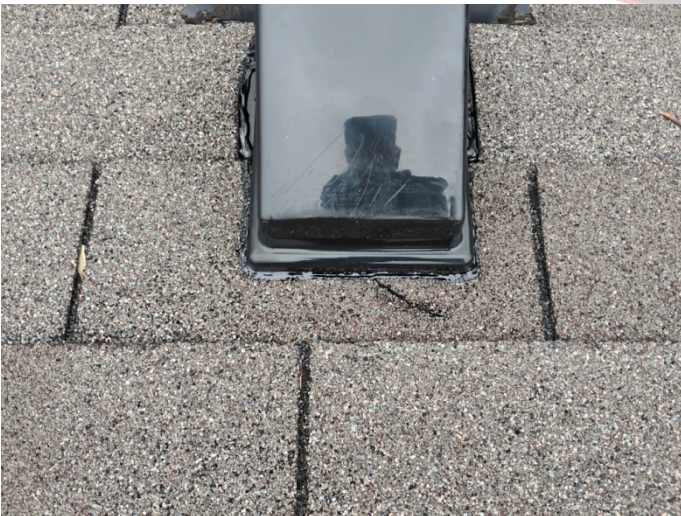
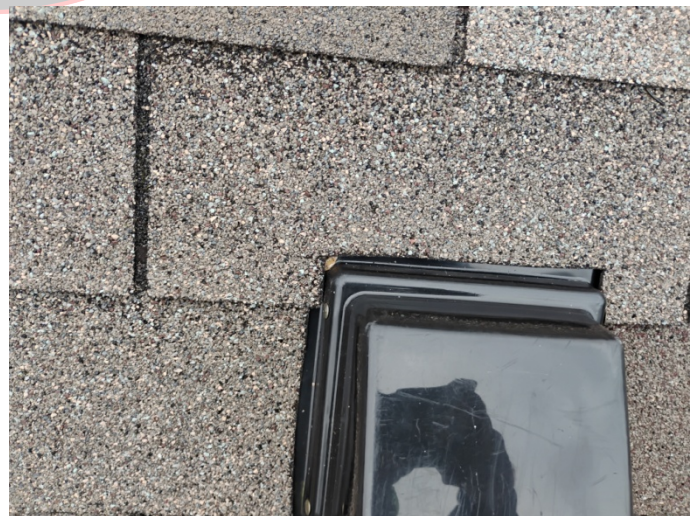
The roof was inspected by walking on it. The roof covering was asphalt shingles which appear to be fairly new. It was reported that the roof had been replaced two years ago. The gutters had gutter guards installed which appeared to be installed correctly and working as intended. The downspouts were in good shape, secured to the wall properly, and fed into underground drain pipes. There were box vents as well as a ridge vent and soffit vents which make up the ventilation system. The roof felt solid while the inspection took place and it appeared to have no major issues at the time of inspection. All of the flashing was observed to be in place and properly installed including the cricket on the chimney. Regular maintenance and inspections are recommended in order to have debris and leaves removed from the roof at regular intervals and after severe weather events. This should be performed by a qualified licensed professional.

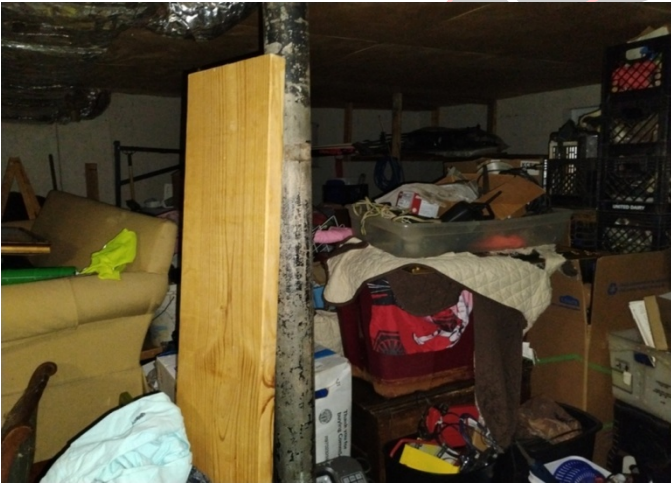
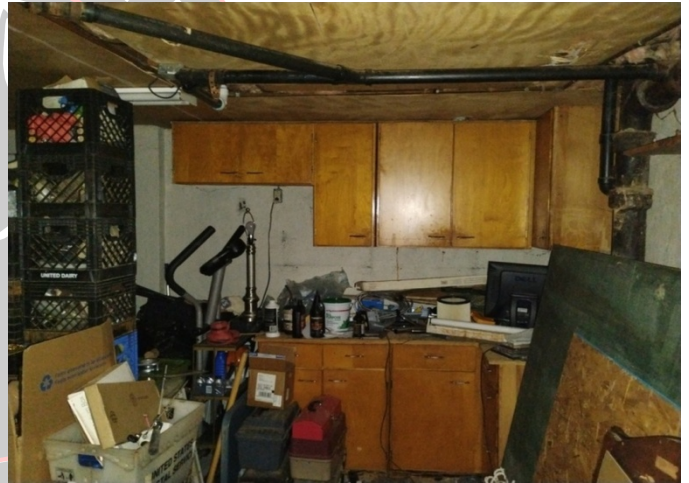
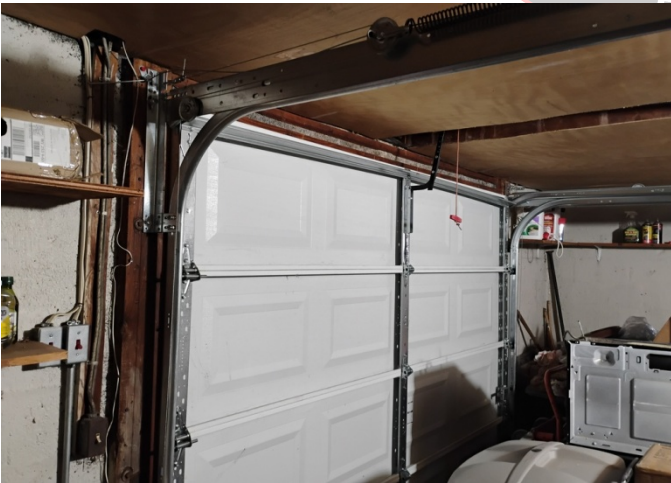
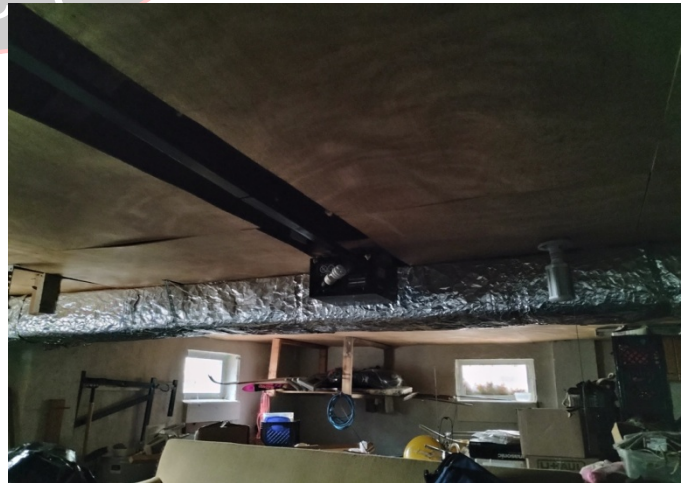
The inspection of the garage was limited due to personal items preventing access to most of the garage. The insulation was improperly installed. The vapor barrier is designed to be facing the conditioned room, not the unconditioned room. In this case it should be against the floor. The floor was concrete and appeared to have the correct slope. The door leading into the basement was not fire-rated nor automatically closing as mentioned in the previous section. These are modern standards and were not in effect at the time of construction; but this is a safety issue and should be evaluated further by a qualified licensed professional. The vehicle door has an automatic opener and the safety reverse and safety stop both worked as intended at the time of inspection.

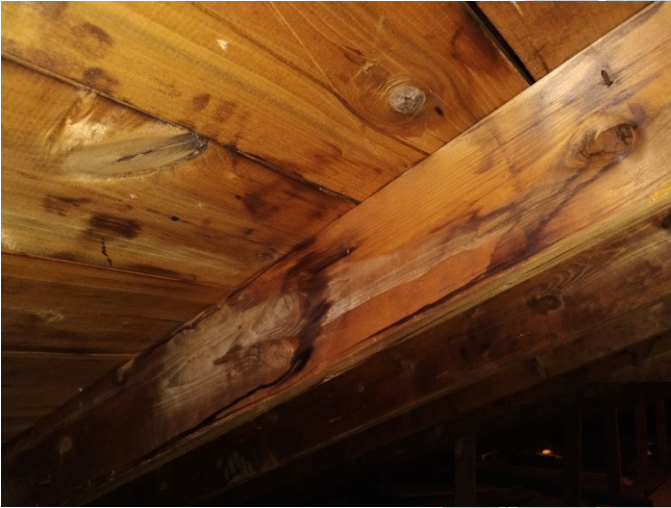
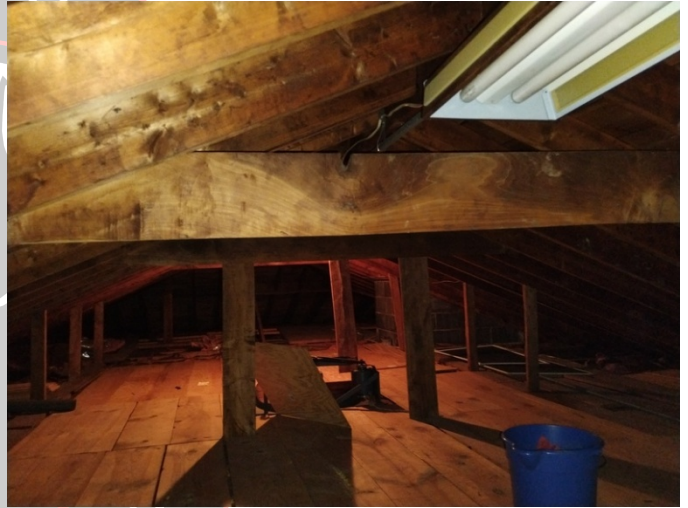
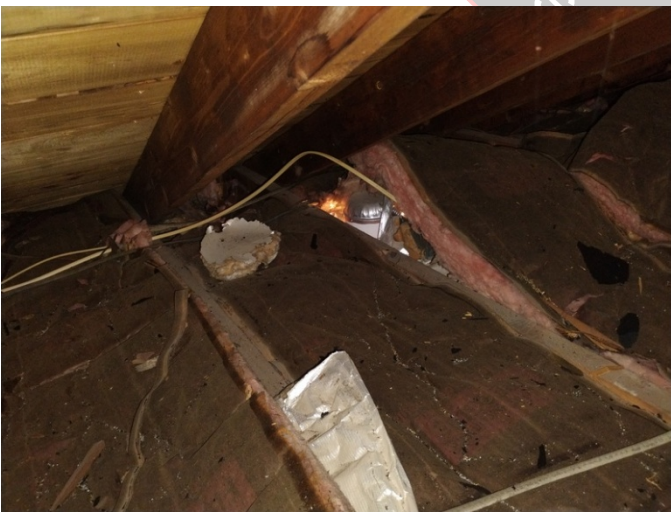
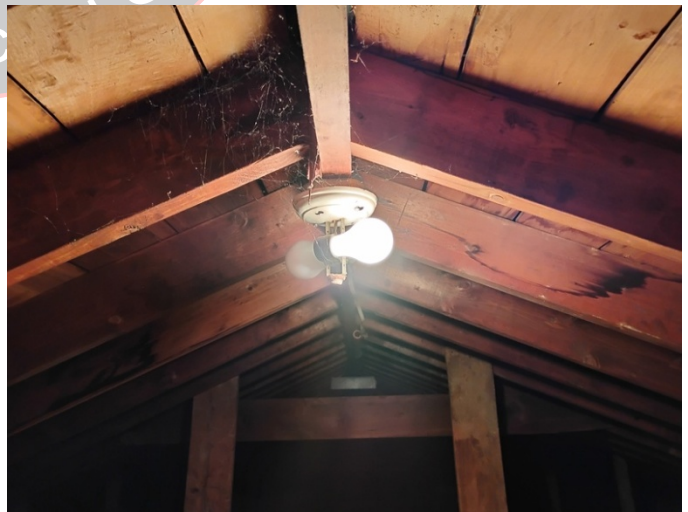
The attic had a stairway installed for access in the hallway. It was a stick built hip roof with very few collar ties. The insulation has been installed upside down. Normally it would be recommend to be turned over, however in this case most of the attic has been covered with wood planks presumably for storage and most of it is inaccessible. There were signs of prior water damage on the rafters. This could be left over from before the roof was replaced but there is no way to tell at this time. It is recommended to be kept under observation and further evaluation performed as needed by a qualified licensed professional. There were bare bulbs in fixtures in the attic which is a safety concern. Covers should be installed by a qualified licensed professional.

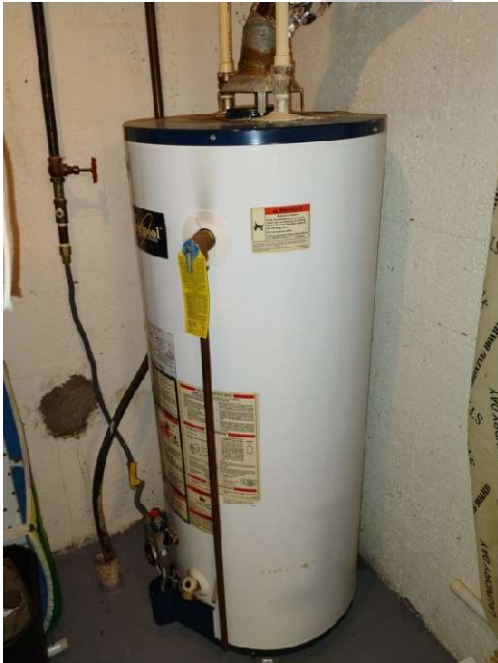
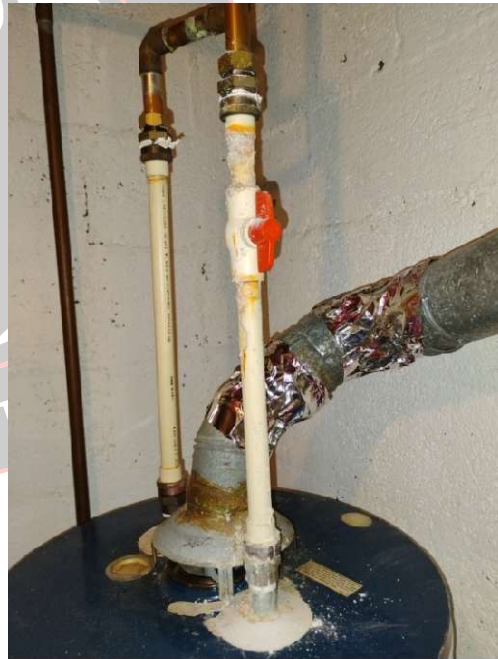
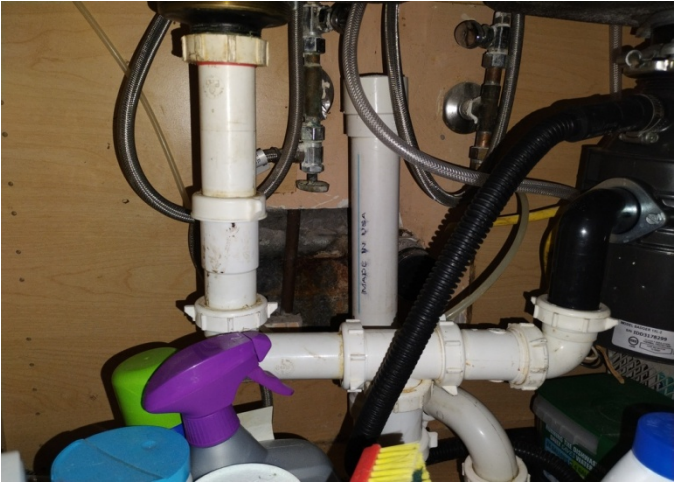
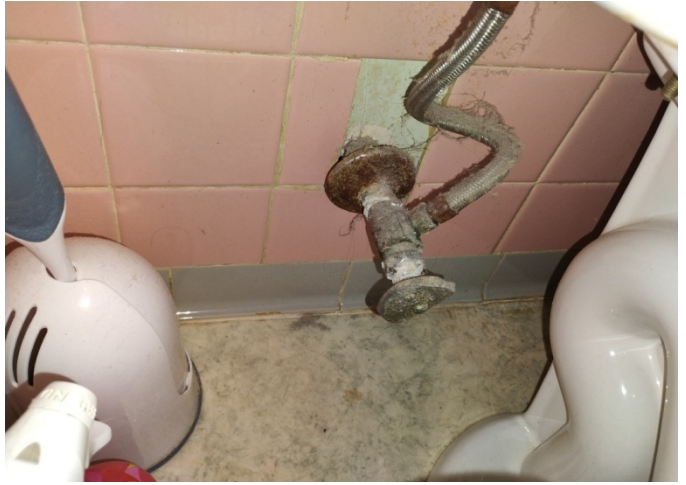
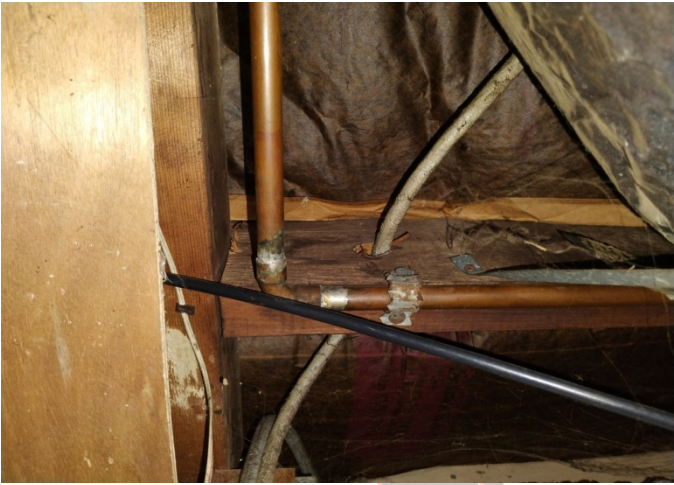
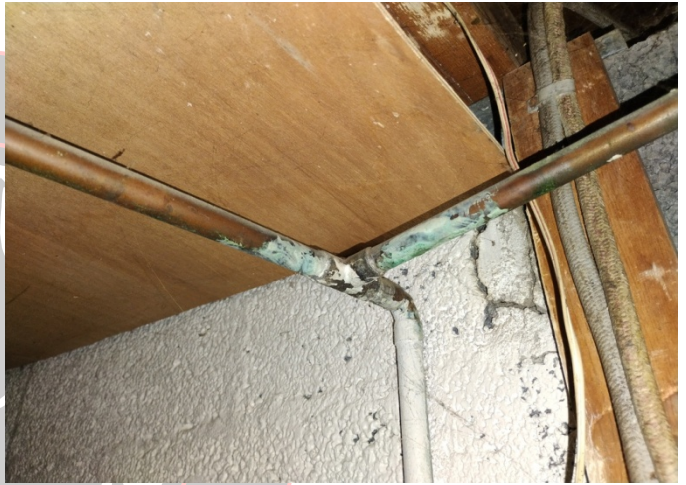
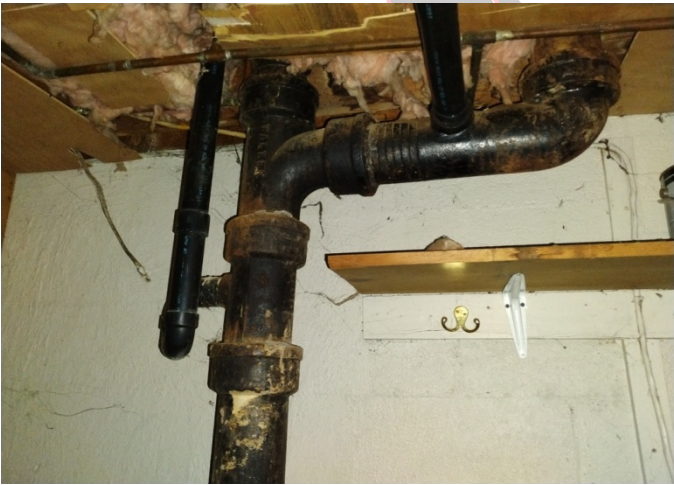
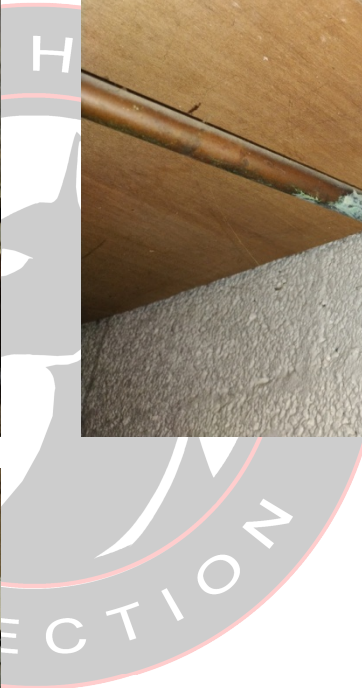
The water supply into the house is from the Saint Albans municipal source and enters the house via a 3/4" metal line from a meter on the street. There was a shutoff valve near the hot water tank. The water lines were copper and original to the house. They showed signs of corrosion and seepage in multiple locations throughout the house. The drain lines were cast iron and also original to the house. The water tank had rigid supply lines which showed signs of corrosion and a previous leak but were not wet or damp at this time. It is recommended they be replaced with flexible steel lines and a shutoff installed on each line by a qualified licensed professional. The dishwasher could not be operated because it was in use at the time of the inspection. The toilet in the upstairs bathroom was not properly secured to the floor and should be repaired by a qualified licensed professional. The functional flow in the bathroom was adequate, however the functional drainage was insufficient in the bathtub and left standing water. The garbage disposal was inoperative.

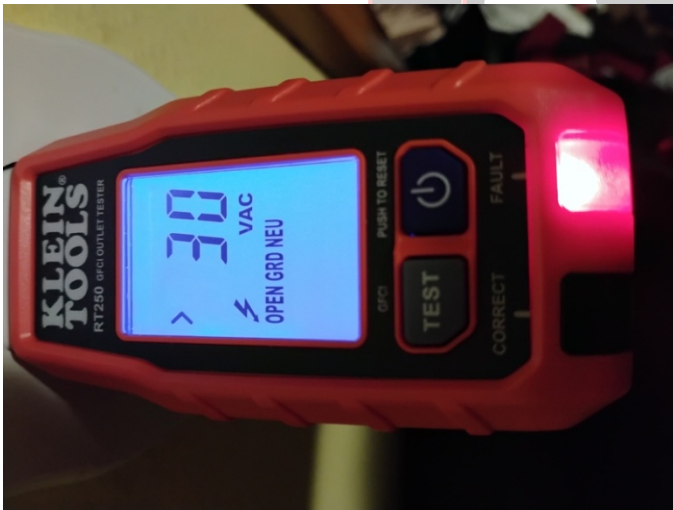
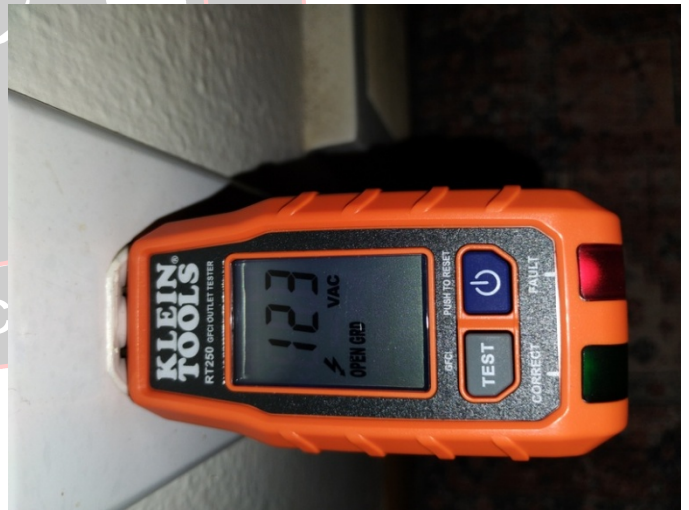
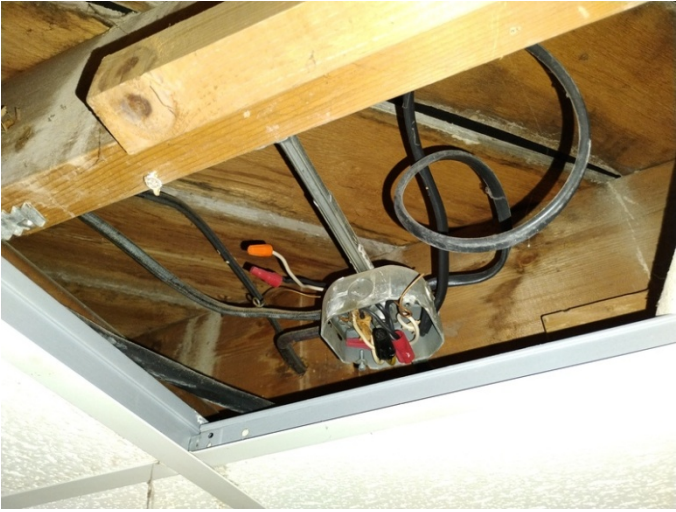
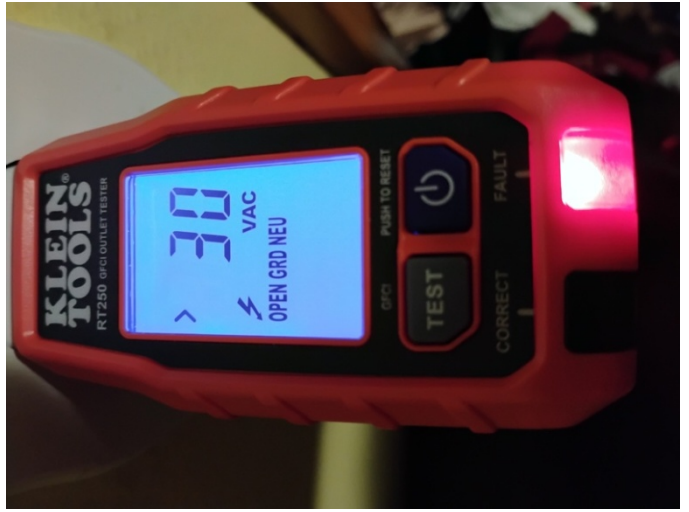
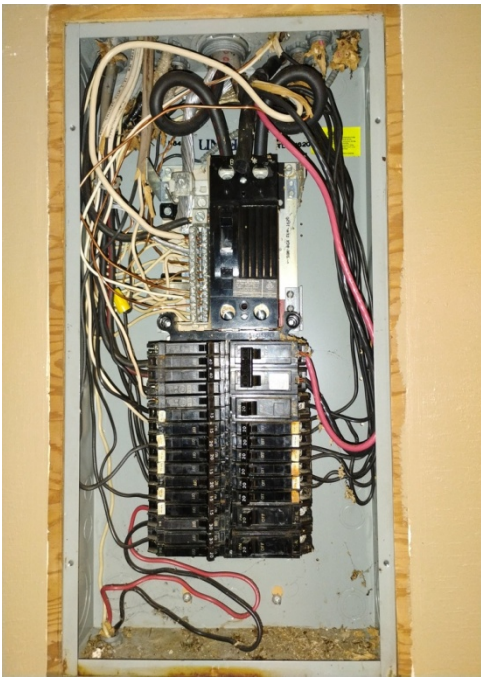
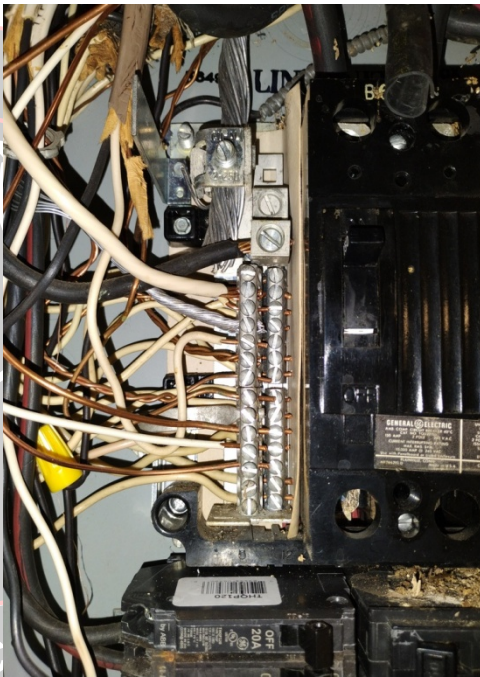
The house has a 200 amp overhead service which enters on a mast on the rear of the house to the left of the back door. The GE panel in the basement had mixed neutral and ground wires on the same bar and a splice with a wire nut on a hot wire. Aluminum wiring was found inside the panel feeding the circuit and although it appeared to be of the correct size, it should be evaluated by a qualified licensed professional.

Open grounds were observed throughout the house and there were no AFCIs in the basement at all. Although that is a newer requirement that was not in effect at the time of construction, it is a good idea to have them installed. There were open junction boxes and wire splices not in boxes in several locations throughout the house. This is also a safety issue and should be addressed by a qualified licensed professional.

Several of the switches were not fully functional and several surface mount boxes were not secured to the wall. There is one unidentified cable going into the ground on the west side of the house. These things should also be addressed by a qualified licensed professional.

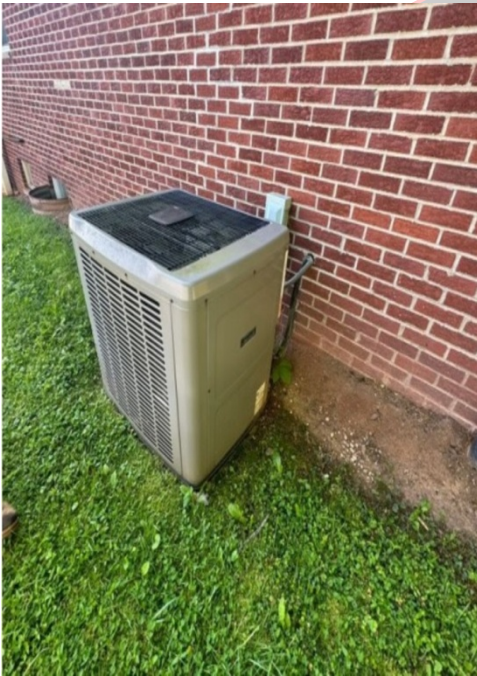
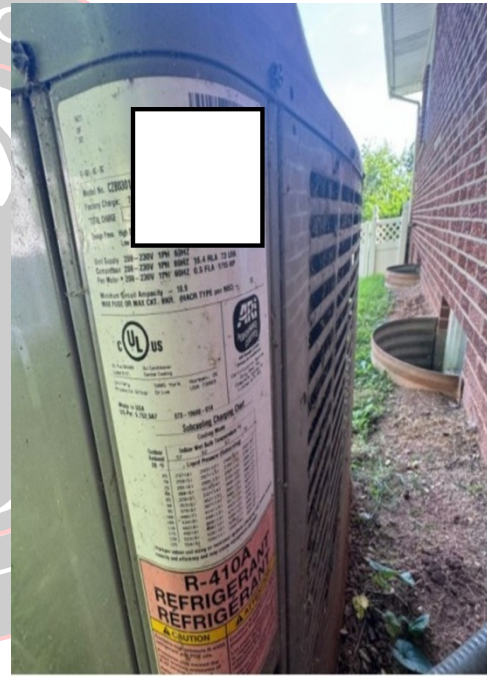
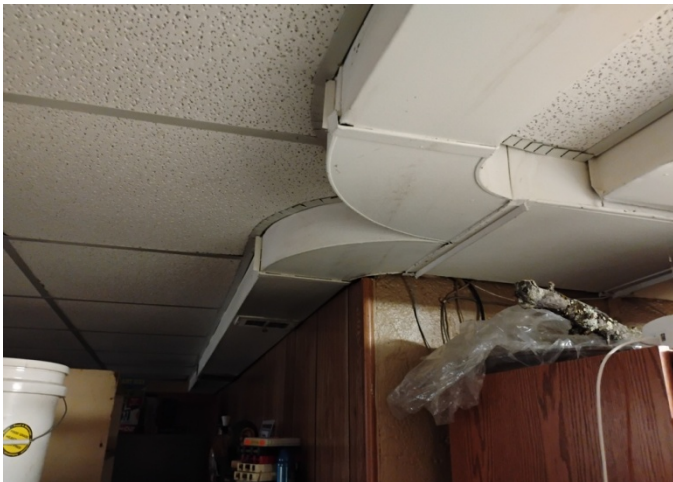
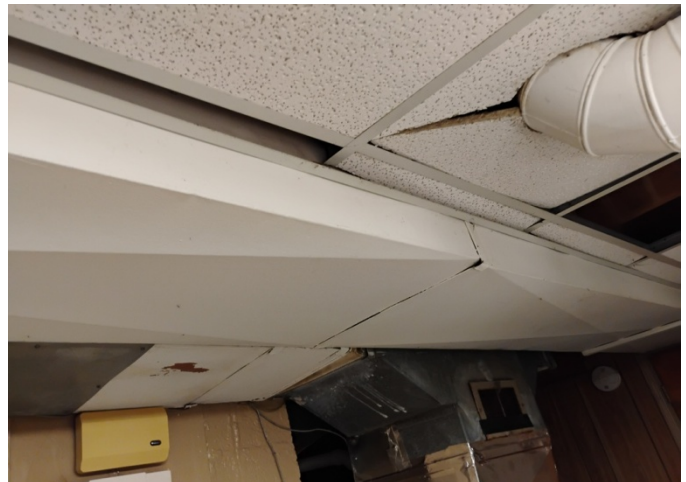
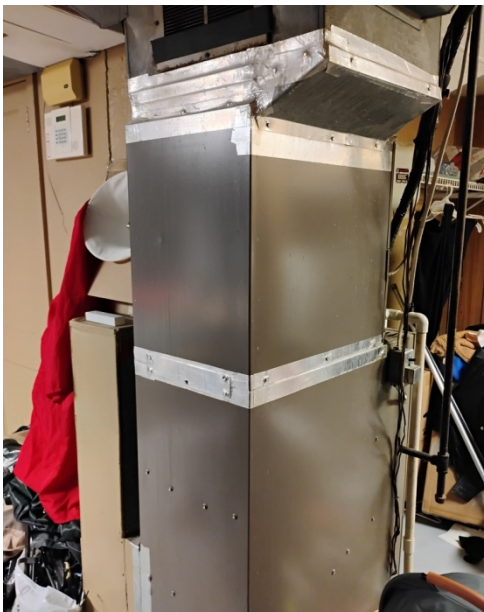
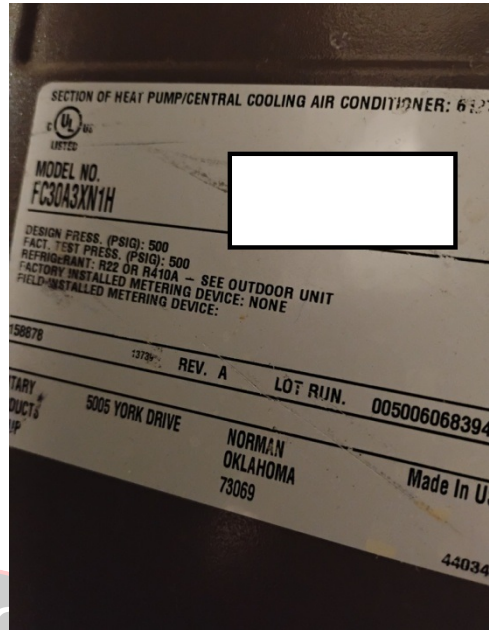
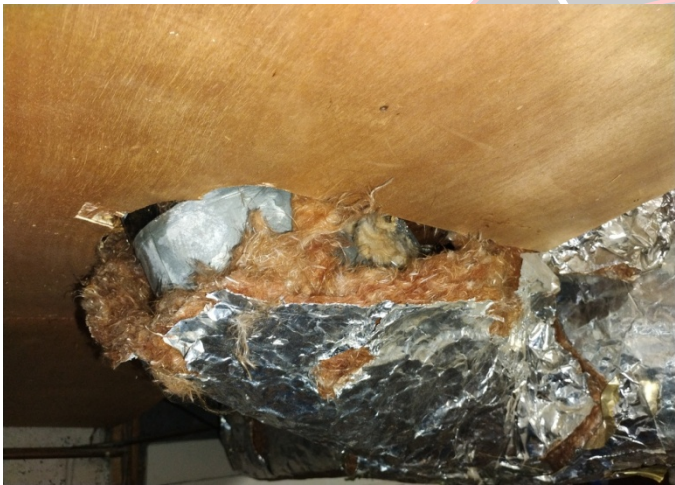
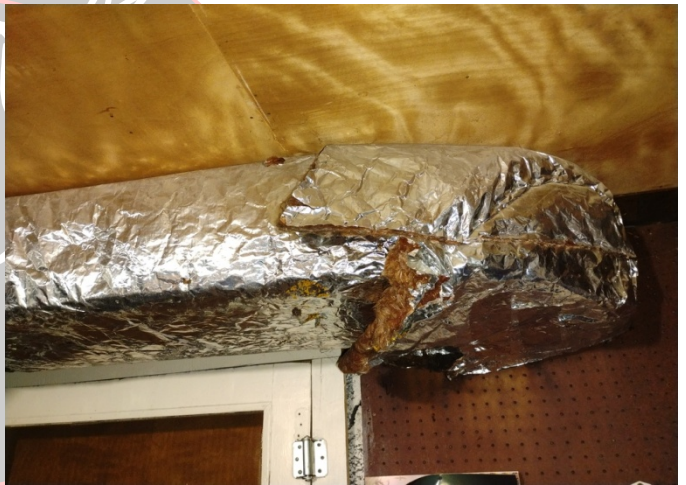
The heating, ventilation, and air conditioning (HVAC) system consisted of a York air conditioner and furnace installed in 2007 and a whole house fan that appeared to be original to the house. When the air conditioner was tested, it was not lowering the temperature sufficiently and should be evaluated by a qualified licensed professional. Some of the ductwork had insulation that needs repaired, but even though this is a maintenance item it should be performed by a qualified licensed professional. The furnace was a gas forced air system which was operational and there is a heat source in all rooms except the one half of the upstairs bathroom. There was a fireplace downstairs and the fireplace upstairs has been converted to gas. At least a level 2 inspection of the chimney is recommended by a qualified licensed professional before using either.

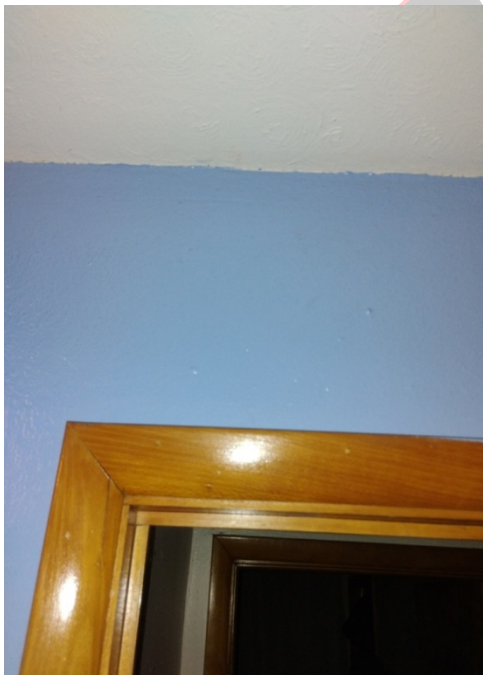
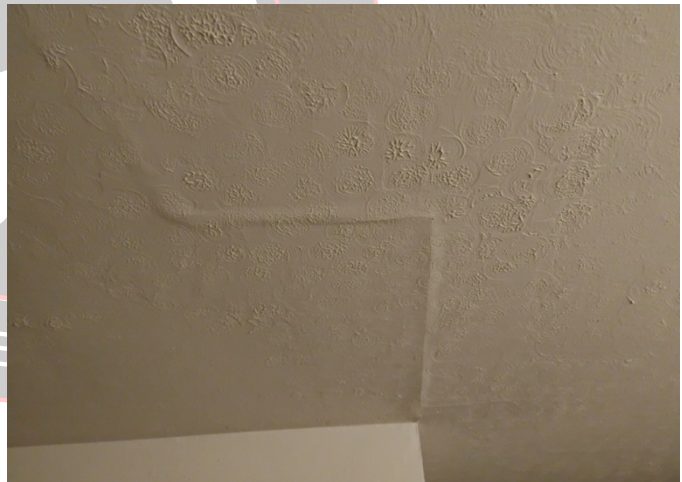
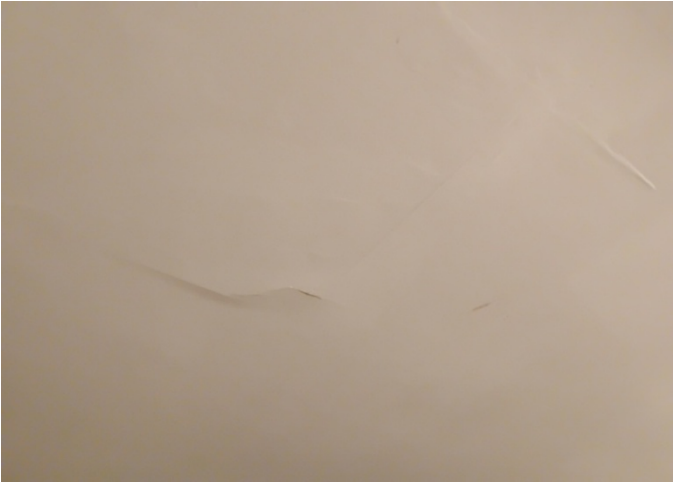
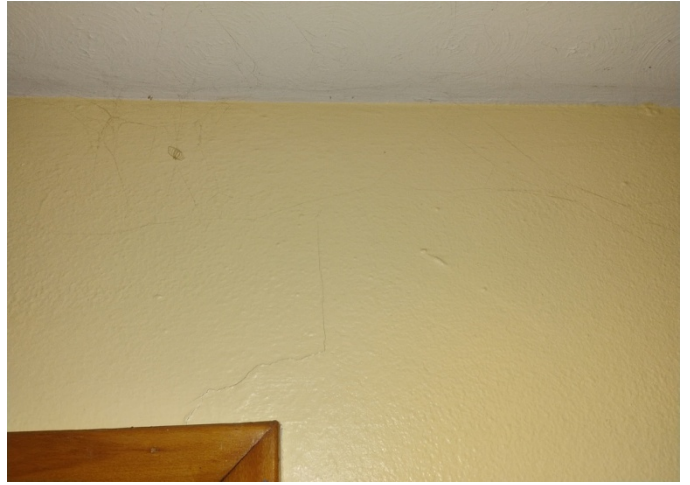
The floor was sloping toward the front of the house, possibly due to the foundation settling. There were cracks which have been repaired in the living room, dining room, and kitchen. All accessible windows and doors were operated and tested all accessible receptacles were tested. One window in the living room would not stay up when unlocked. There were multiple open grounds on receptacles throughout the house. The doorways had cracks in the corners which usually indicate settling. The door from the master bedroom to the bathroom was coming apart. The upstairs bathroom had stained glass windows, one of which had some small cracks in it. There were two smoke detectors and no carbon monoxide detectors. In a house with an attached garage, carbon monoxide detectors should be used at least in areas adjacent to the garage for safety.

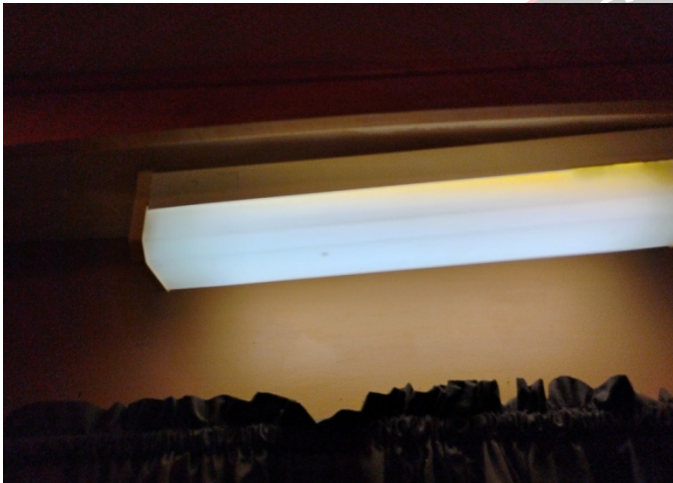
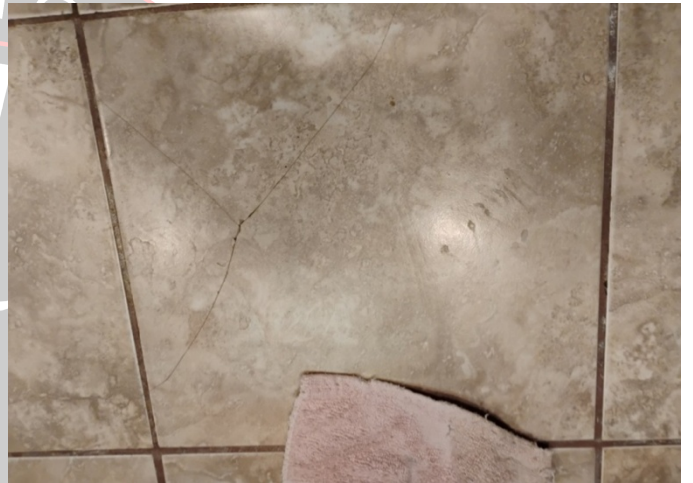
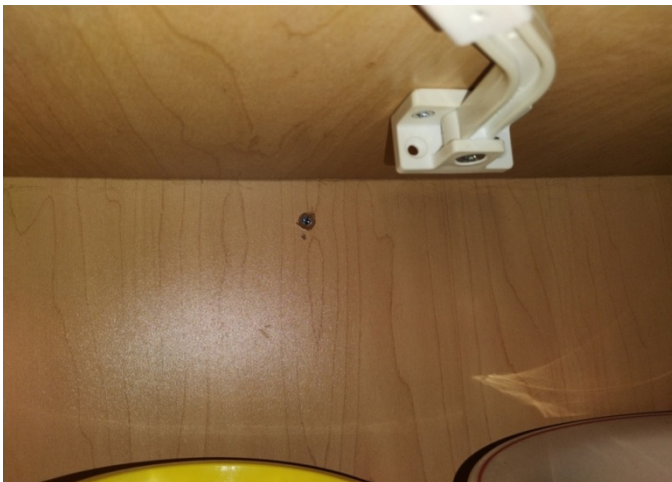
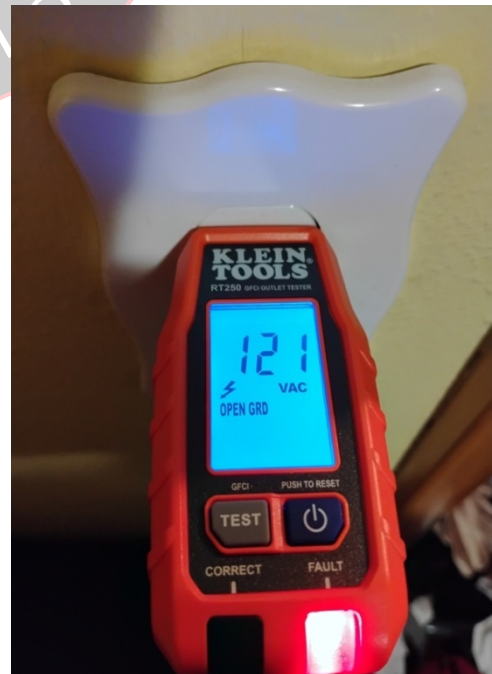
The garbage disposal was inoperable. The oven was a double oven and is missing the door to the bottom oven but was otherwise operational. There were eight broken tiles on the floor. The water supply lines to the sink were corroded and the shutoffs were not operated at this time due to poor condition. There were signs of a previous water leak but everything was dry at the time of the inspection and no leaks were observed. Several of the outlets should be GFCIs but were not. Although this was not required when the home was built it should be upgraded for safety. The light fixture over the sink was not securely mounted. All of these items should be evaluated further by a qualified licensed professional and their recommendations acted upon as needed.
